Newton Senior Center
Newton, Massachusetts

Existing Conditions Assessment Report

Bargmann Hendrie + Archetype, Inc.
Boston, Massachusetts

City of Newton, Massachusetts
October, 2020

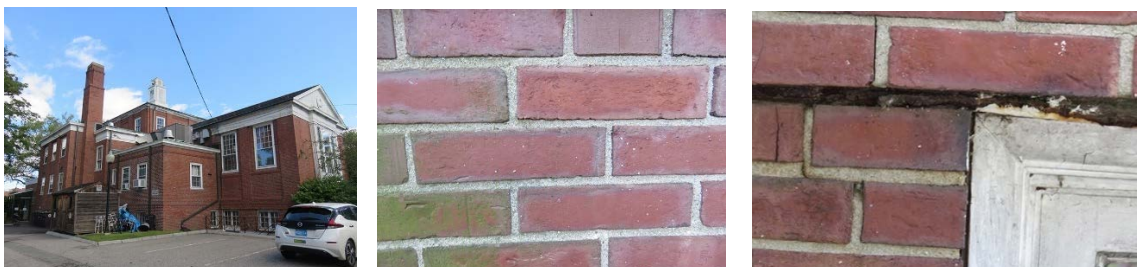
The red brick at the walls is generally in good condition. Bricks are sound, with minimal cracking or spalling. There is some staining of the brick and spatters from previous painting work. Mortar joints are in fair condition. The mortar color is quite uniform, indicating little has been done to repoint over time. While there are not significant areas of missing mortar that would dictate a complete repointing is now needed, a close-up review indicates there are areas where mortar is cracked and allowing water in. These conditions are located near windows that have rusting steel lintels.

General view of brick, close-up, and detail showing deteriorated mortar joints and rusted lintels.

CONDITION: Fair.

RECOMMENDATION: Clean brick. Cut out and repoint a percentage of joints.

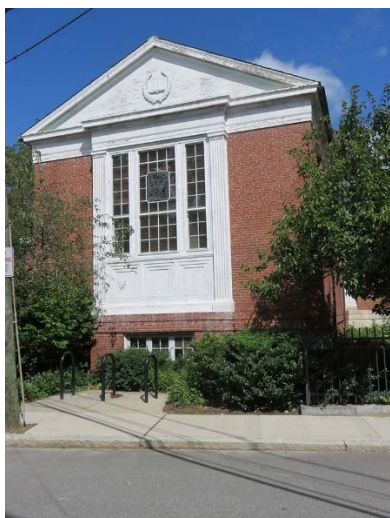
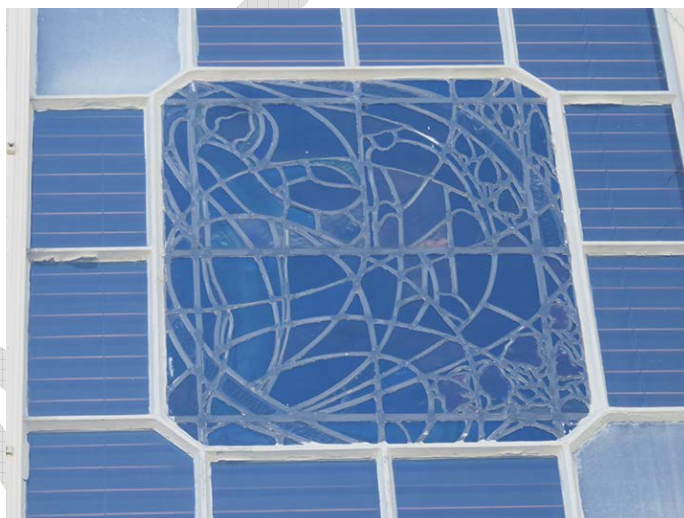
The most distinctive windows on the building are at the north and south ends, where wood-framed, multi-lite windows at the ends of the reading rooms are highlighted by leaded glass art panels. Wood and glass appear to be generally intact, though some areas of replacement glass are evident. The art glass looks to be in excellent condition.

Detail of art glass at north window

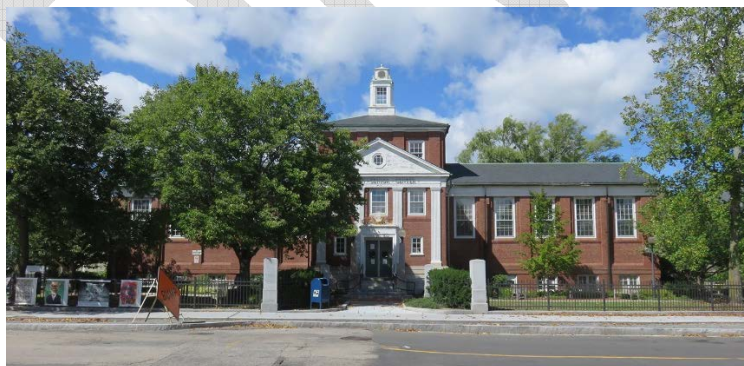
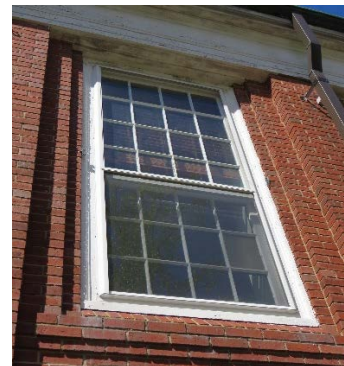
The most prominent windows on the main façade are those at the reading rooms. These double-hung wood windows look to be largest of the windows, those at the reading rooms, look to be the original wood double-hung windows with wood muntins and individual glass lites. These windows have had aluminum storm windows added at the exterior.

Front façade with reading room windows at the right side.

RECOMMENDATION: Retain and restore existing windows. Strip paint at exterior and repaint.

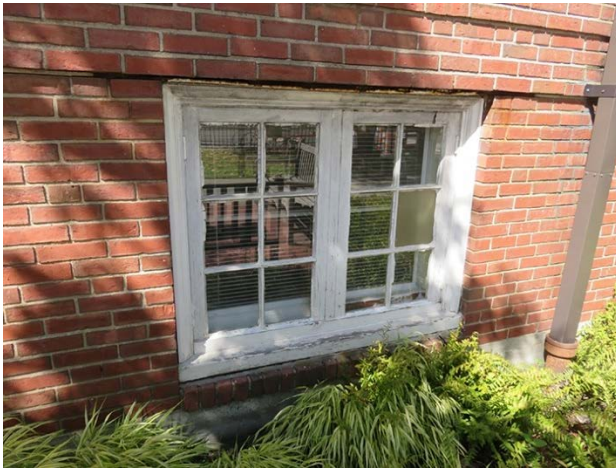
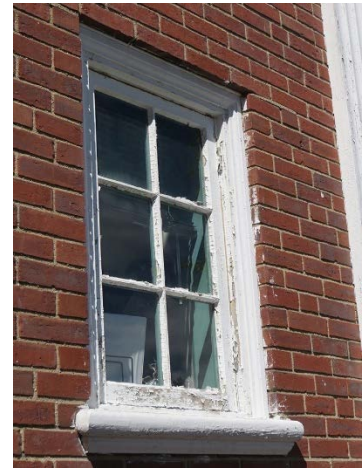
Other smaller windows include the basement windows, small casement windows at the entry area, and windows at the west façade. Smaller windows have no added exterior storm panels. Conditions are good, with the exception of peeling paint and some mismatched replacement glass. If windows throughout are to remain, a minimal scope would be stripping of paint, some wood repairs, repainting, re-glazing, and re-caulking.

Basement window.

Window next to east entry doors.

CONDITION: Fair.

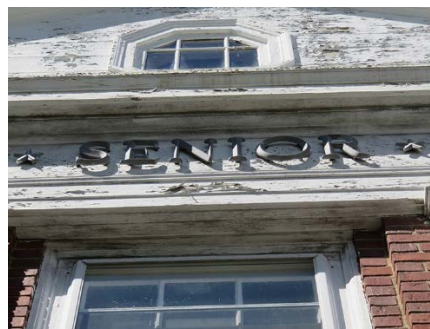
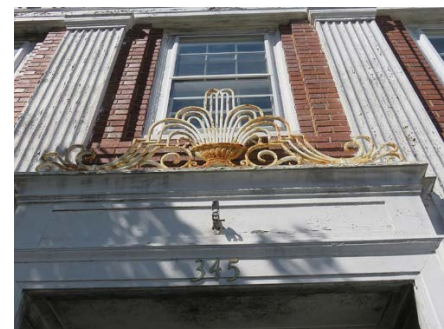
Pedimented center pavilion, letters from 1993 renovation, and original decorative metal above entry.

CONDITION: Fair.

RECOMMENDATION: Strip paint at all wood. Assume some wood requires replacement. Retain decorative aluminum stars for reuse. Retain and repair wrought aluminum ornament. Restore lantern lights.

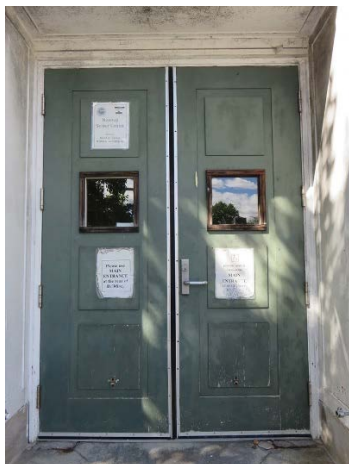
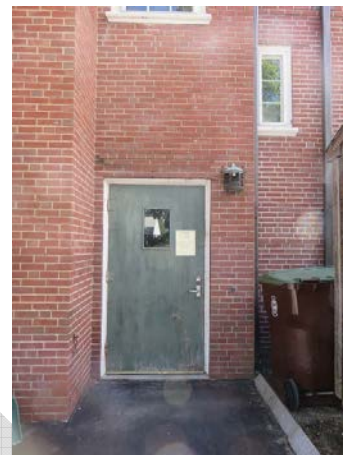
The painted wood doors at the original east entry look like they might be original but, if so, have been significantly altered over time. The doors are used only for emergency egress, if at all, but their appearance detracts from the front façade due to retrofit panels, peeling paint, and visible weatherstripping. Other doors at the building exterior also suffer from peeling paint that reveals deteriorated wood. None of the doors look to be salvageable.

Main entry doors at east façade, along with drawing of original doors.

Grade-level door at west egress stair.

CONDITION: Poor

RECOMMENDATION: Remove all existing doors. Provide painted wood doors to match the original at the east façade, whether entry is used or not.

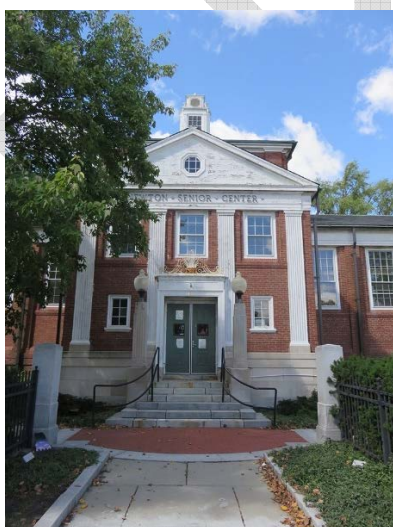
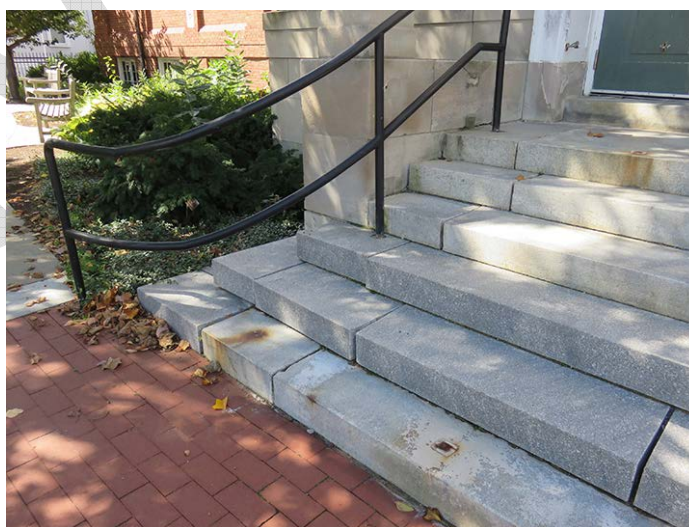
The main entry stairs were originally granite. These have been repaired over time and some granite has crisp, unworn edges and looks to be relatively new. Joints are open throughout, however, and some stones have shifted. There have been multiple handrails over the years, none of which are original. The rust stains and cut-off steel posts are residual from the 1993 work.

Granite steps have open joints and residue from metal railings.

CONDITION: Fair.

RECOMMENDATION: Reset and clean granite steps. Remove existing railings and provide new railings if this is to be used as an entry or emergency exit.

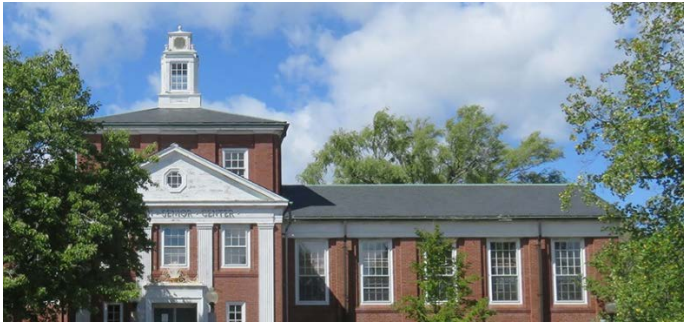
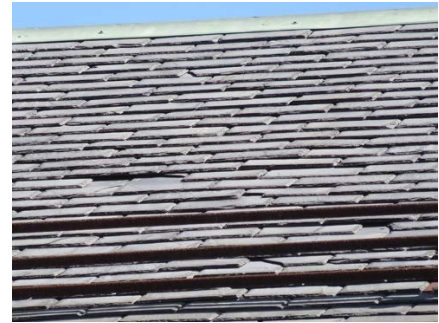
The roofing on the building is quite worn, and for that reason is assumed to be original. This includes slate shingles along with copper gutters and trim.

Missing and broken slates.

CONDITION: Poor.

RECOMMENDATION: Remove existing slate and copper gutters, along with related trim. Provide slate and copper to match. Provide new flat roofing over Kitchen if this wing remains.

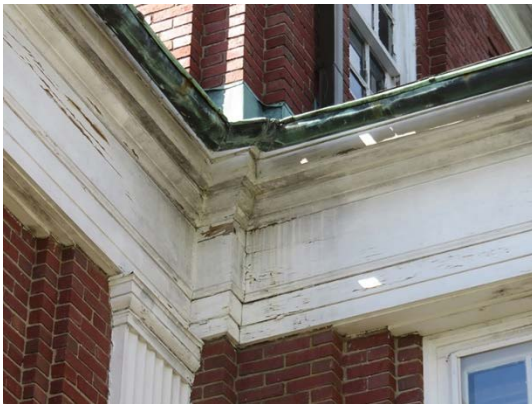
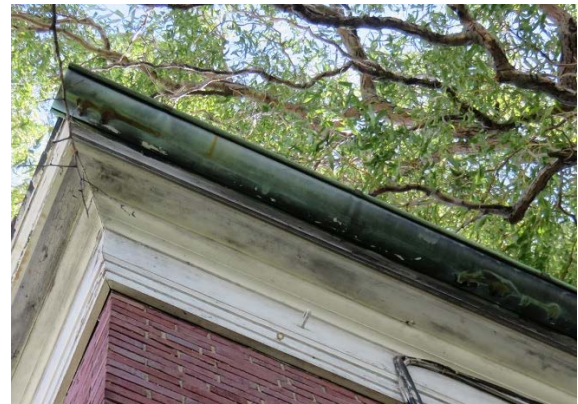
Copper gutter and deteriorated wood below.

Detail of underside of gutter.

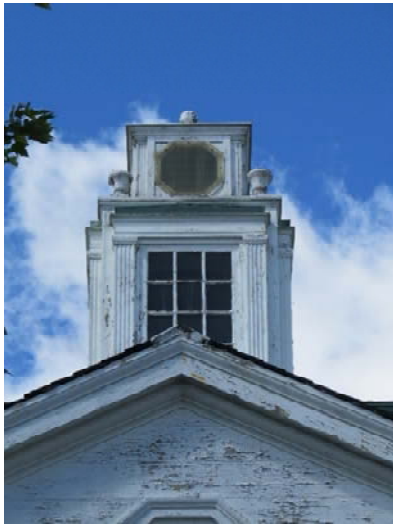
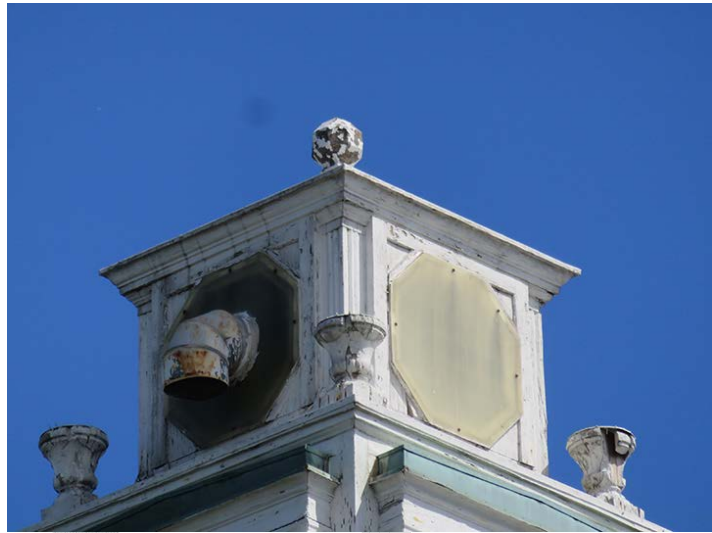
This is one of the character-defining elements of the building. It is a four-sided painted wood structure, with painted wood urns, and cap. Currently the upper portion has acrylic panels and an exhaust duct at the upper faces. All materials except the acrylic/duct look to be original, matching the early photos. The early photos indicate that the panels may have been clock faces. , even though the shape and materials are different from what was on The original drawings show an octagonal cupola with louvers at the top, and an octagonal shape. The drawings identify the material being aluminum for all except a copper spike-shaped lightning rod at the top, where the existing has a sphere.

CONDITION: Fair.

RECOMMENDATION: Strip paint, repair wood. Remove retrofit plastic panels and reintroduce original faces.

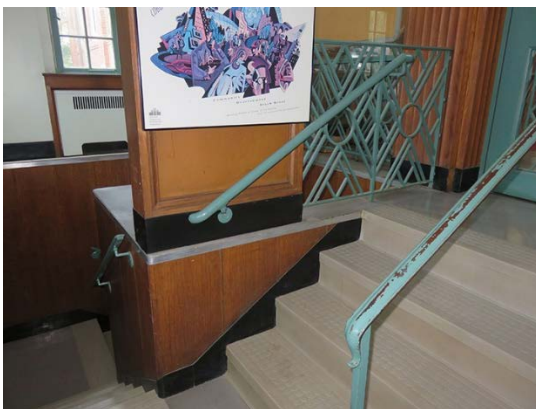
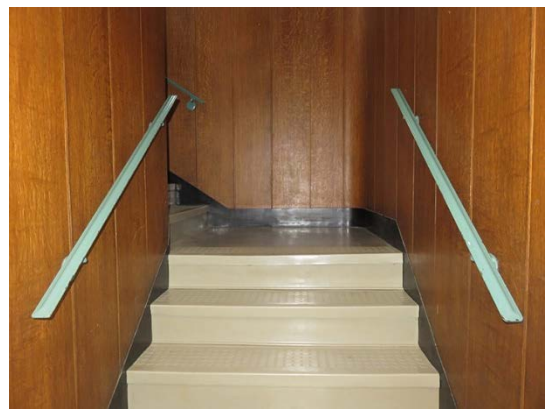
The main entry stairwell retains much of its original character, though some materials have been covered over or removed. The south stair remains usable, connecting the ground and first floors. Treads have been covered with rubber, but oak plywood walls, decorative aluminum railings and guardrail remain. Handrail ends do not comply with code requirements and guardrails do not meet code for height. A renovation would require modifying these elements.

South stair at ground floor level has rubber treads.

CONDITION: Fair.

RECOMMENDATION: Assess feasibility of retaining stairwell as part of building entry or egress. Remove rubber treads/risers to expose or replicate original materials. Remove office floor and partitions at north. Retain decorative railing and door elements while modifying to make code-compliant.

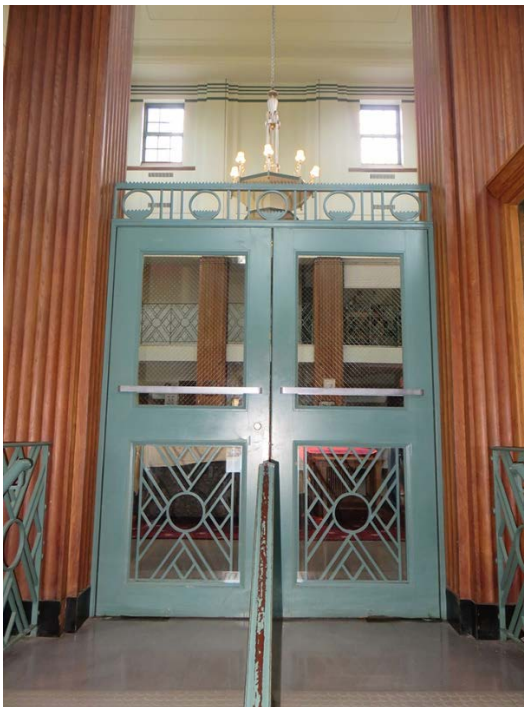
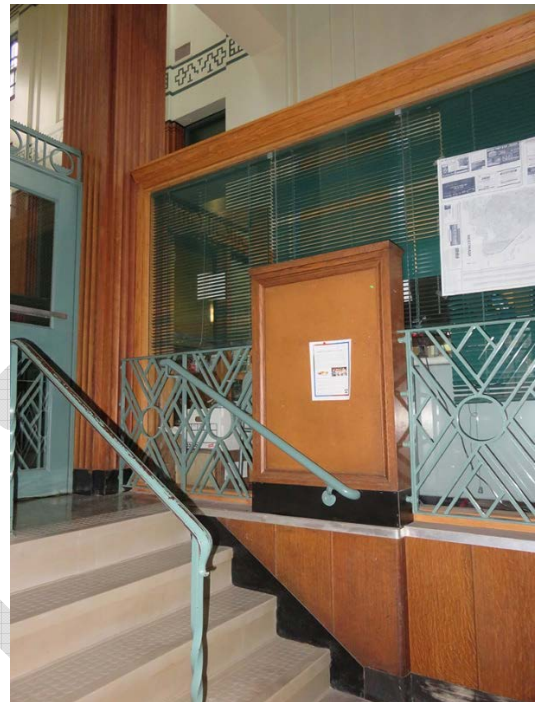
The first floor level doors at the stairwell include the same decorative detail as the guardrails, though hardware has had some retrofit work. The north stair has had an inter-floor installed at the first floor level (a post 1993 renovation to add a security office), though it appears that the stair is intact below. Removal of this floor would be possible. The original guardrail remains.

Doors separate stairwell from Lobby.

Added office at north stair includes a glass wall.

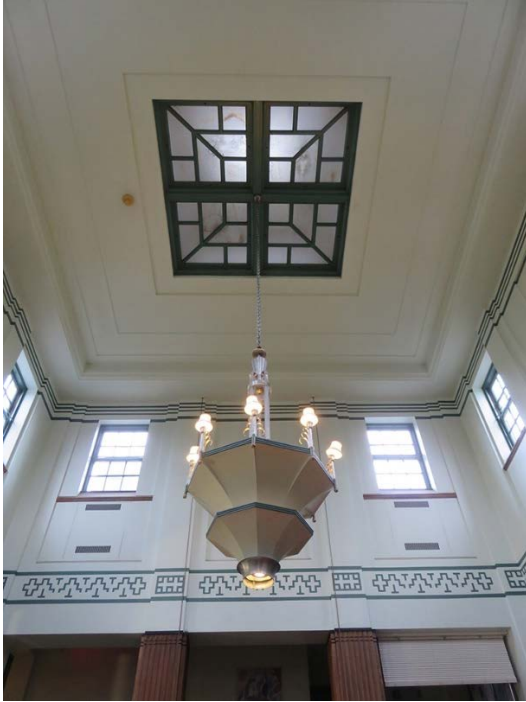
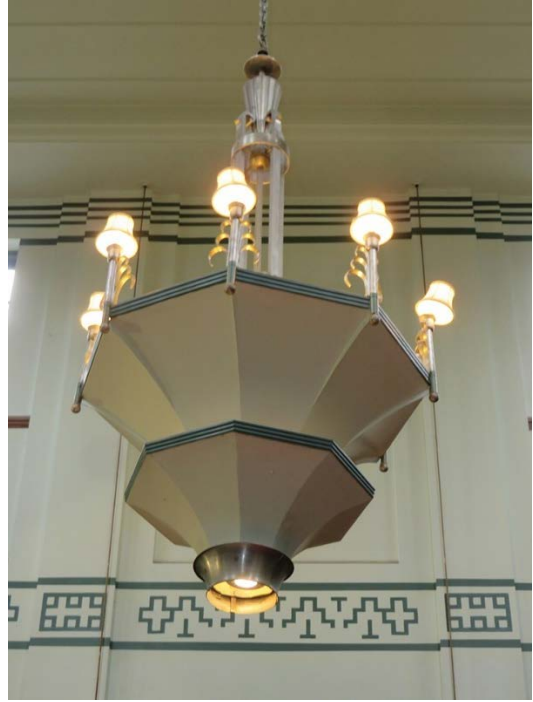
Upper wall and ceiling at Lobby.

Detail of upper wall and chandelier.

CONDITION: Good.

RECOMMENDATION: Remove existing vct flooring and provide cork or other suitable flooring. Restore chandelier and retrofit with LED lamping. Conceal HVAC system and reuse original grilles.

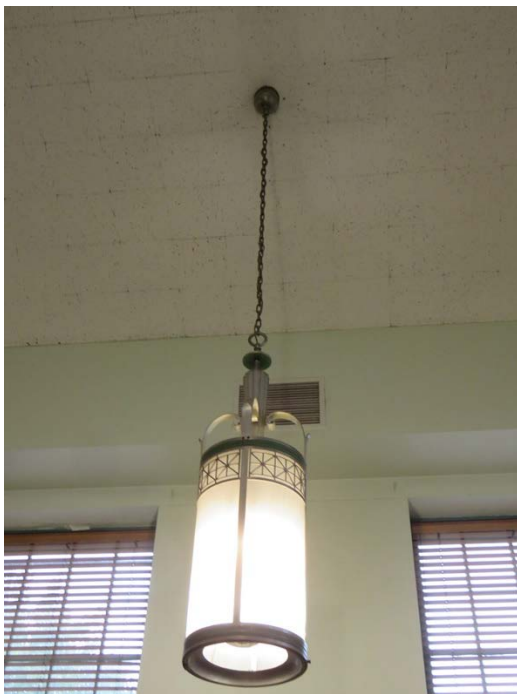
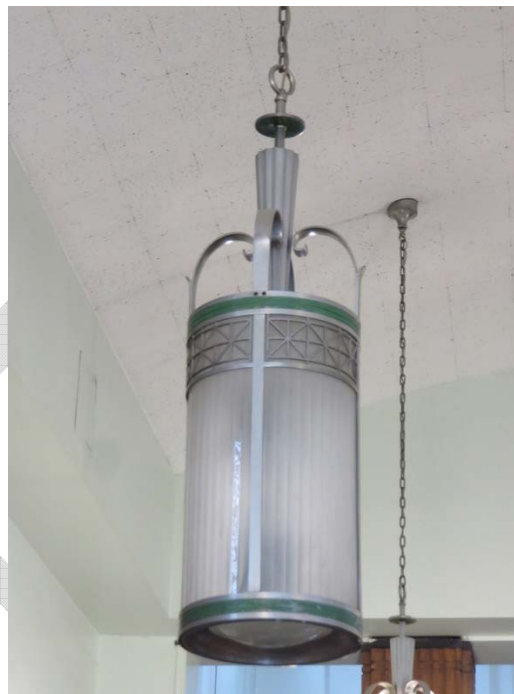
The original pendant light fixtures remain, and at least some are functional. These, along with the art glass at the end windows, are the most distinctive elements in the spaces.

Pendant light fixture lit.

CONDITION: Good.

RECOMMENDATION: Remove existing vct flooring and provide cork or other flooring. Restore pendants and retrofit with LED lamping. Conceal HVAC system and reuse original grilles. Remove duct soffits and reintroduce stenciling. Retain shelving. Salvage lights and shelves for reuse elsewhere if spaces are not retained.

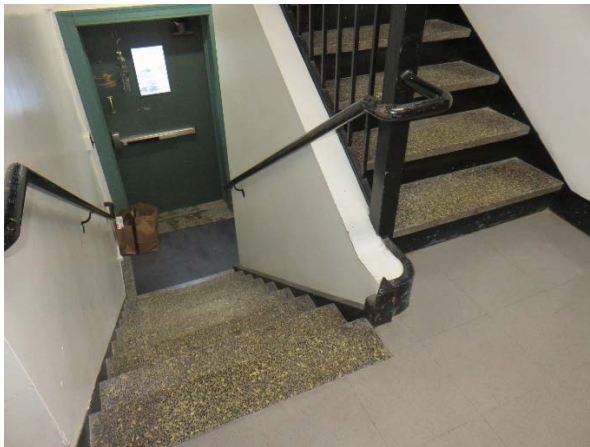
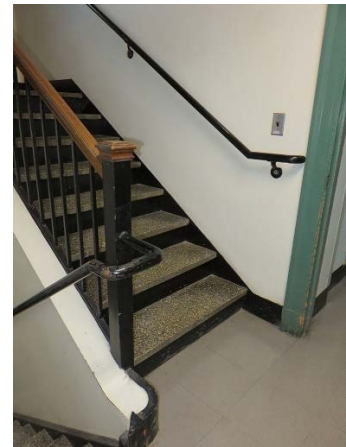
This stair connects the three levels of the library floors as well as providing egress at grade level at the west. Terrazzo treads look to be original and are in good condition. Wall-side railings added in 1993 in order to comply with code.

Added handrail at wall.

CONDITION: Good.

RECOMMENDATION: If this is retained, some upgrades to comply with code requirements may be needed.

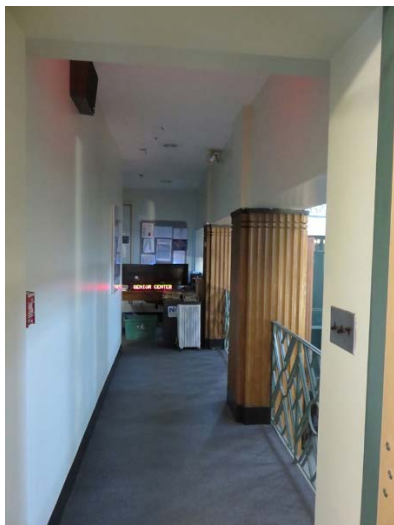
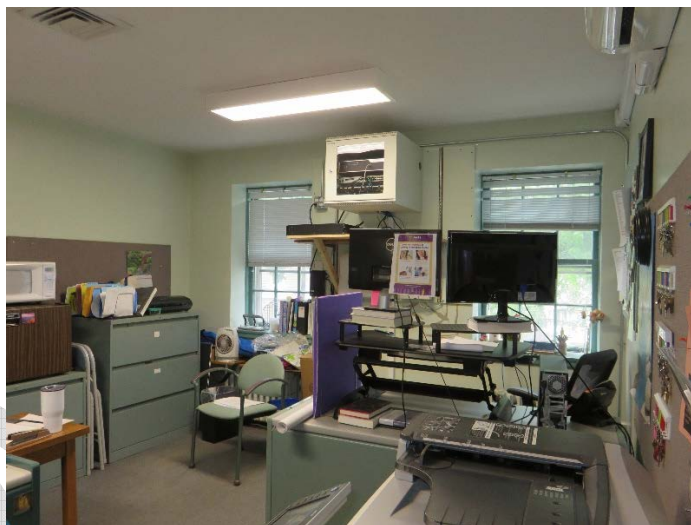
The mezzanine area originally was the upper level of the stacks, and is now used as offices. The small office area has drywall finishes and fluorescent lighting. The one distinctive element of the mezzanine area is the open railing overlooking the Lobby space. The railing is not a code-compliant height and would require a supplemental railing as part of a renovation. The elevator does access this level. The overall occupancy of this level is minimal, so the one egress stair is code-compliant.

Hallway at mezzanine.

CONDITION: Good.

RECOMMENDATION: If this is retained, an additional railing of some sort would be required to meet code requirements of 42" in height.
