NewCAL Feasibility Study

June 2021

City of Newton

Building Conditions Assessment Report

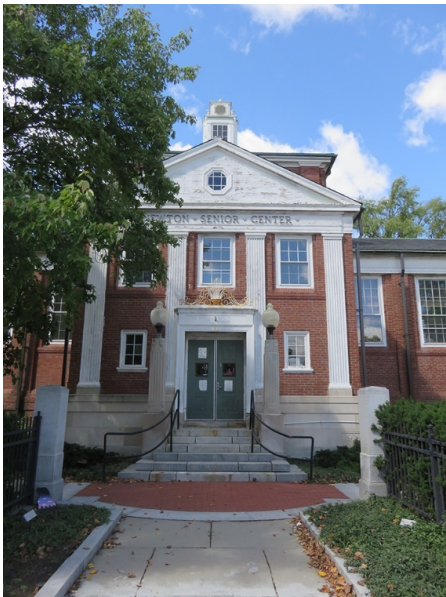
The original front entry at Walnut Street is not accessible and currently is not used as an entry into the building. The current main entrance is at the parking lot side, where a grade-level entrance was added as part of the 1993 renovations. This includes glass doors and sidelights that create a vestibule with double doors and an air-lock to help protect the interior from the elements. This piece was designed in 1993. The entrance, as well as the elevator shaft, are visible changes relative to the original rear façade.

Original Walnut Street entry is currently not used

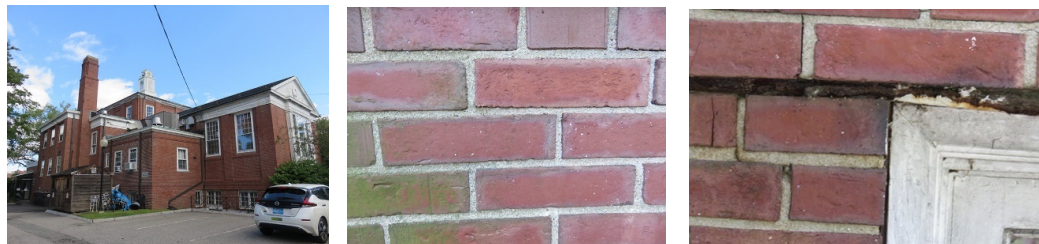
The red brick at the walls is generally in good condition. Bricks are sound, with minimal cracking or spalling. There is some staining of the brick and spatters from previous painting work. Mortar joints are in fair condition. The mortar color is quite uniform, indicating little has been done to repoint over time. While there are not significant areas of missing mortar that would dictate a complete repointing is now needed, a close-up review indicates there are areas where mortar is cracked and allowing water in. These conditions are located near windows that have rusting steel lintels.

General view of brick, close-up, and detail showing deteriorated mortar joints and rusted lintels.

CONDITION: Fair.

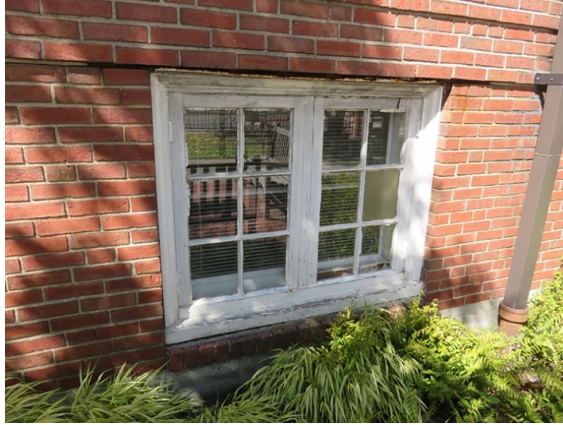
Other smaller windows include the basement windows, small casement windows at the entry area, and windows at the west façade. Smaller windows have no added exterior storm panels. Conditions are good, with the exception of peeling paint and some mismatched replacement glass. If windows throughout are to remain, a minimal scope would be stripping of paint, some wood repairs, repainting ,re-glazing, and re-caulking.

Basement window.

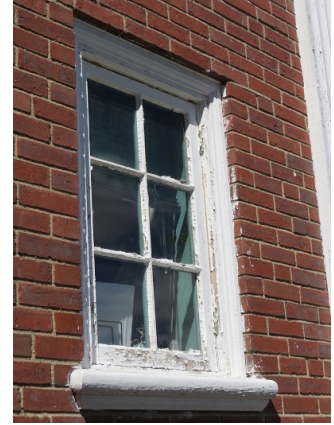
Window next to east entry doors.

CONDITION: Fair.

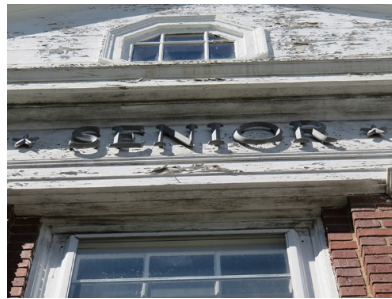
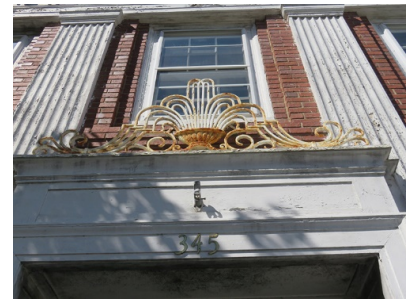
The center three-bay pavilion is the main focus of the Walnut Street façade. In addition to the steps and entry door, the façade includes lantern lights on limestone posts, fluted, painted wood pilasters, painted wood frieze and pediment, with upper story (original stack level that is now offices) and cupola visible behind. The woodwork throughout is peeling, and likely is deteriorated to the point that it will not accept repainting without first stripping and doing repairs.

Pedimented center pavilion, letters from 1993 renovation, and original decorative metal above entry.

CONDITION: Fair.

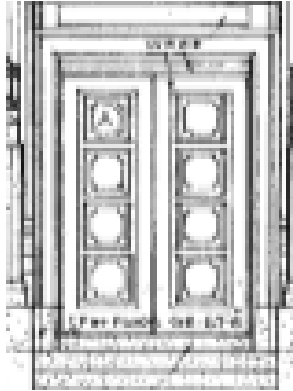
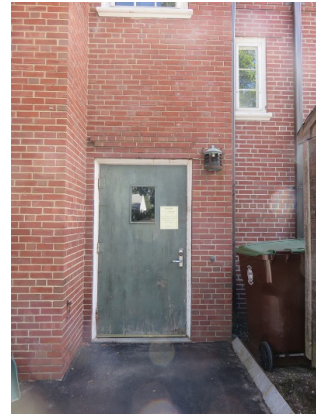
Grade-level door at west egress stair.

CONDITION: Poor

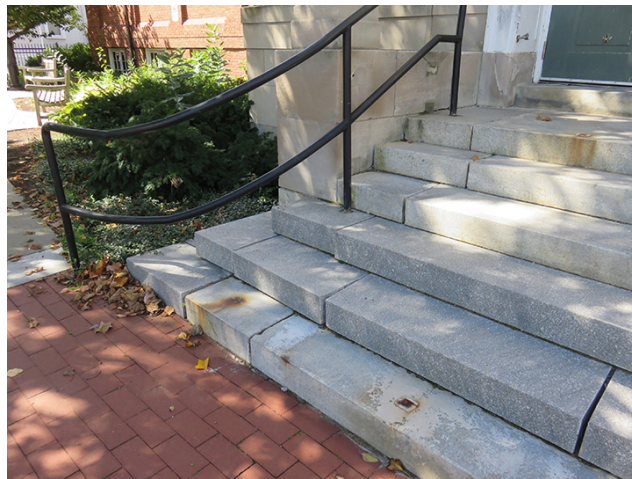
The main entry stairs were originally granite. These have been repaired over time and some granite has crisp, unworn edges and looks to be relatively new. Joints are open throughout, however, and some stones have shifted. There have been multiple handrails over the years, none of which are original. The rust stains and cut-off steel posts are residual from the 1993 work.

Granite steps have open joints and residue from metal railings.

CONDITION: Fair.

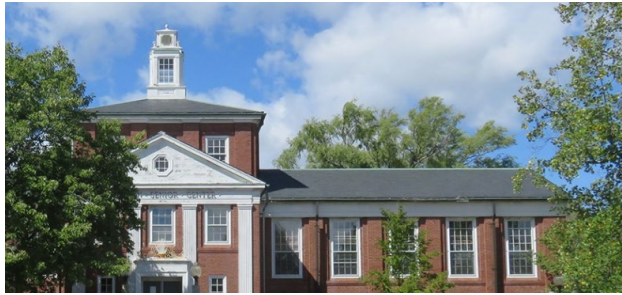
The roofing on the building is quite worn, and for that reason is assumed to be original. This includes slate shingles along with copper gutters and trim.

View of slate roofs.

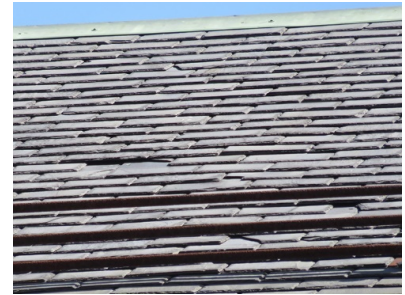
Missing and broken slates.

CONDITION: Poor.

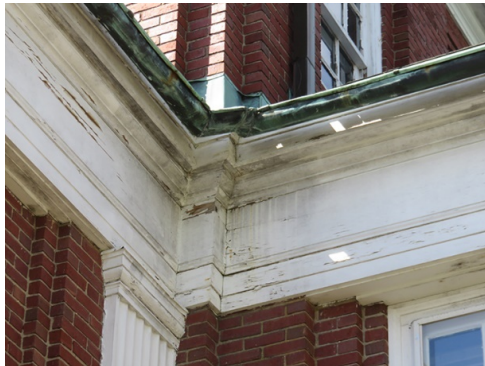
Copper gutter and deteriorated wood below.

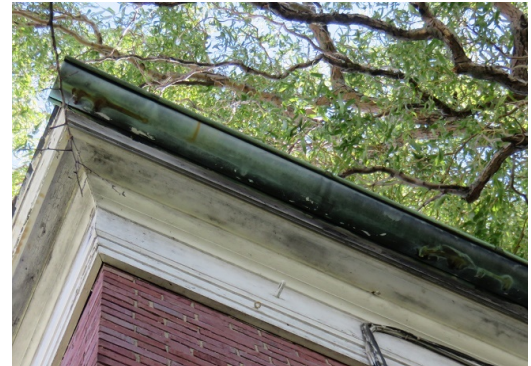
Detail of underside of gutter.

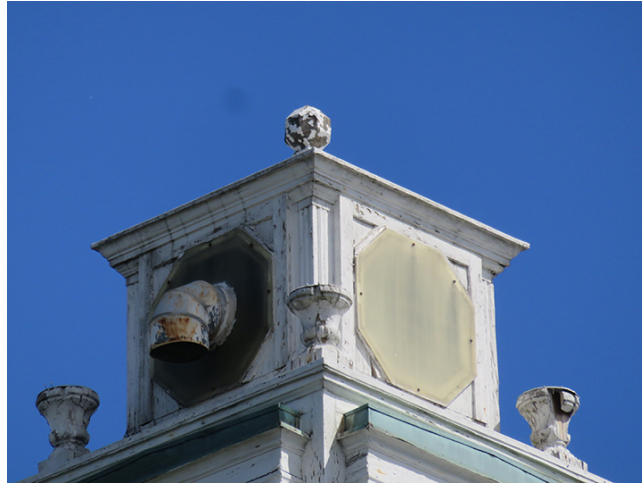
Detail view from southwest.

CONDITION: Fair.

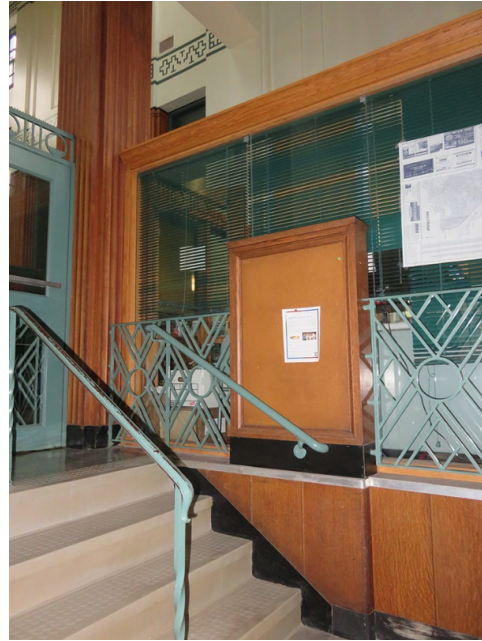
Added office at north stair includes a glass wall.

CONDITION: Fair.

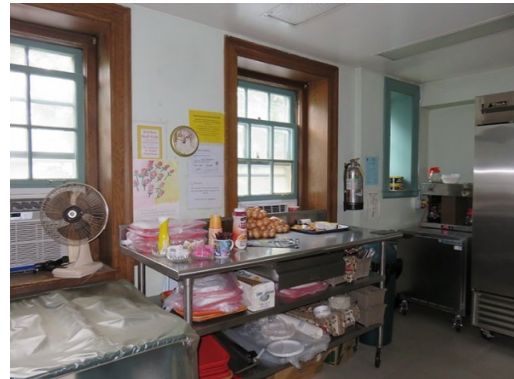
Original windows and casings remain.

CONDITION: Fair.

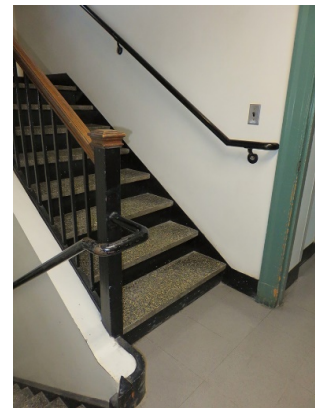
This stair connects the three levels of the library floors as well as providing egress at grade level at the west. Terrazzo treads look to be original and are in good condition. Wall-side railings added in 1993 in order to comply with code.

Added handrail at wall.

CONDITION: Good.

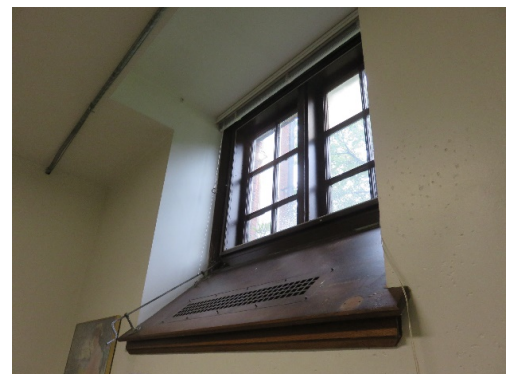
Original wood window sill with heat grille.

CONDITION: Fair.
