NewCAL Feasibility Study

June 2021

City of Newton

Building Conditions Assessment Report

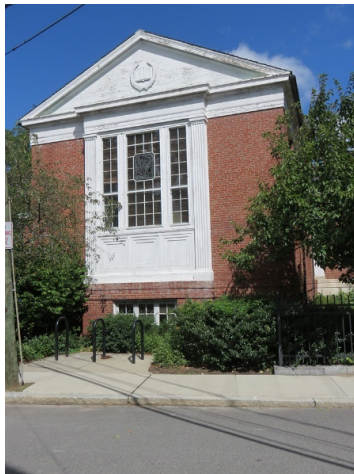
South façade

The most distinctive windows on the building are at the north and south ends, where wood-framed, multi-lite windows at the ends of the reading rooms are highlighted by leaded glass art panels. Wood and glass appear to be generally intact, though some areas of replacement glass are evident. The art glass looks to be in excellent condition.

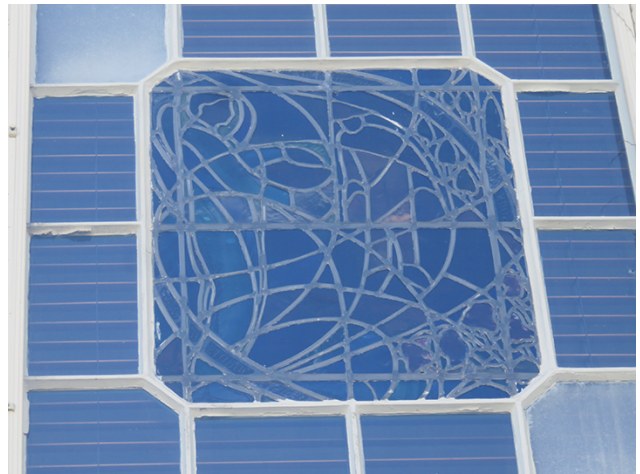
Detail of art glass at north window

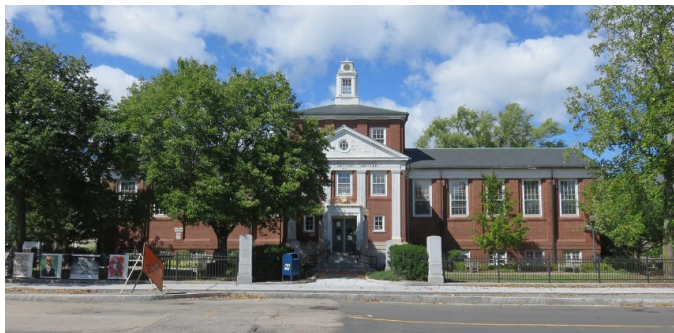
The most prominent windows on the main façade are those at the reading rooms. These double-hung wood windows look to be largest of the windows, those at the reading rooms, look to be the original wood double-hung windows with wood muntins and individual glass lites. These windows have had aluminum storm windows added at the exterior.

Front façade with reading room windows at the right side.

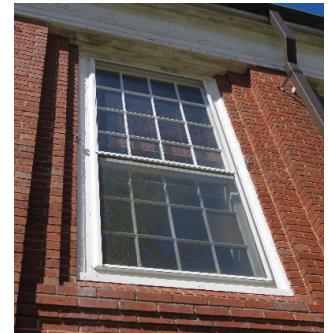
Close-up of window.

Other smaller windows include the basement windows, small casement windows at the entry area, and windows at the west façade. Smaller windows have no added exterior storm panels. Conditions are good, with the exception of peeling paint and some mismatched replacement glass. If windows throughout are to remain, a minimal scope would be stripping of paint, some wood repairs, repainting ,re-glazing, and re-caulking.

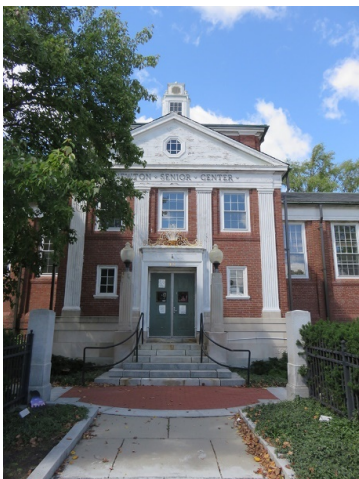
View of east entry.

The main entry stairs were originally granite. These have been repaired over time and some granite has crisp, unworn edges and looks to be relatively new. Joints are open throughout, however, and some stones have shifted. There have been multiple handrails over the years, none of which are original. The rust stains and cut-off steel posts are residual from the 1993 work.

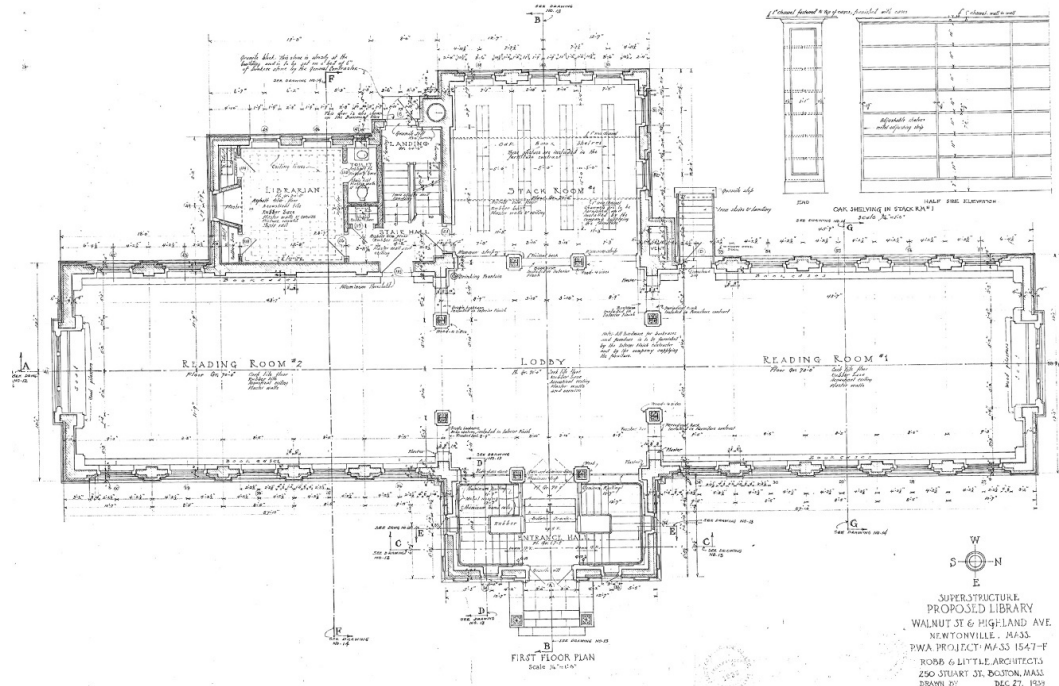
Entry Stair

The main entry stairwell retains much of its original character, though some materials have been covered over or removed. The south stair remains usable, connecting the ground and first floors. Treads have been covered with rubber, but oak plywood walls, decorative aluminum railings and guardrail remain. Handrail ends do not comply with code requirements and guardrails do not meet code for height. A renovation would require modifying these elements.

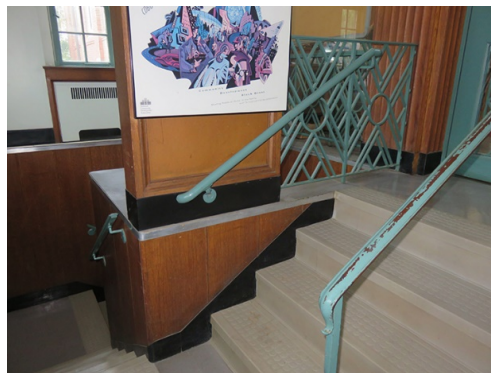
Entry landing with stairs up and down.

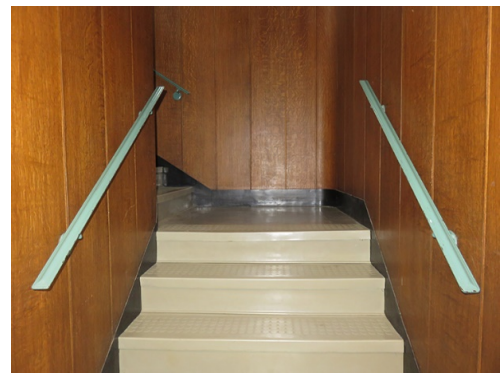
South stair at ground floor level has rubber treads.

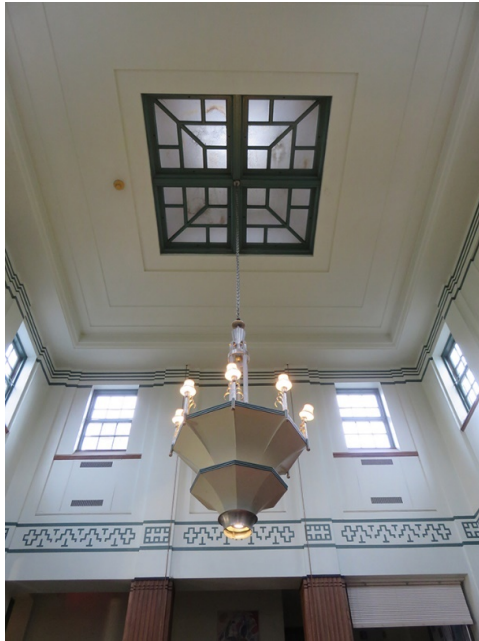
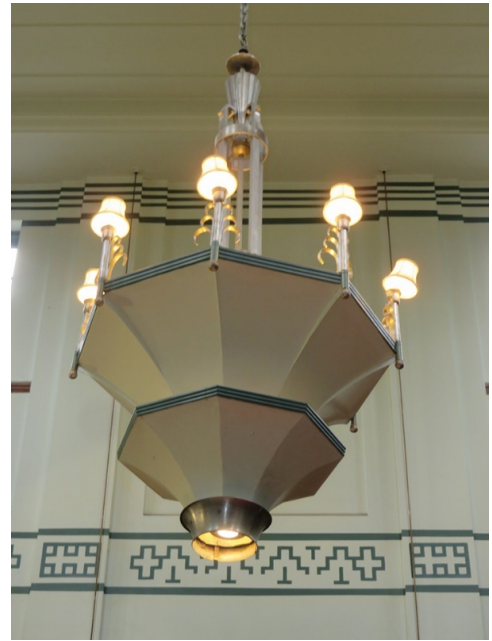
The detailing of this space includes square-shaped fluted oak columns, painted stenciling at the upper walls, and decorative aluminum guardrail at the mezzanine. Metal panels below windows, as is the case in the stairwell, include grilles for the heating system. The focal point of the space is the chandelier fixture that hangs below the skylight.

Upper wall and ceiling at Lobby.

Detail of upper wall and chandelier.

CONDITION: Good.

RECOMMENDATION: Remove existing vct flooring and provide cork or other suitable flooring. Restore chandelier and retrofit with LED lighting. Conceal HVAC system and reuse original grilles.

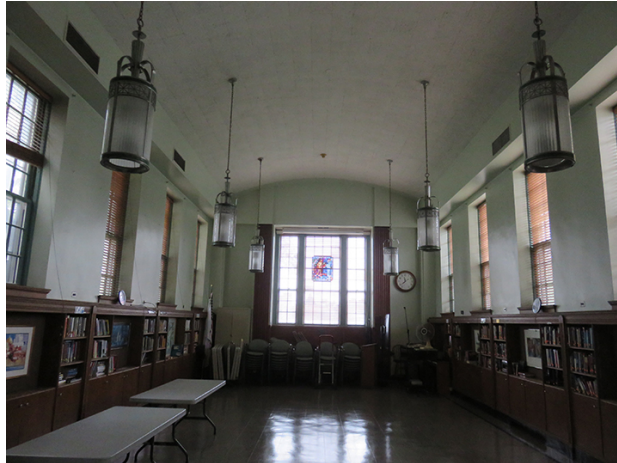
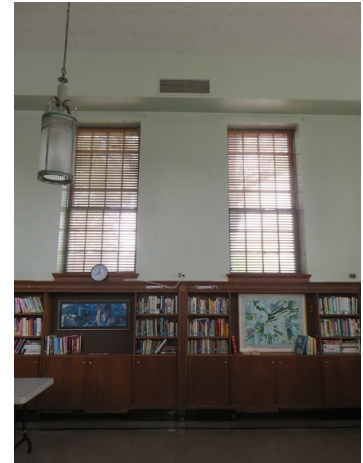
Shelving remains, though modified in some areas to house items other than books. Woodwork details include some fluting that mimics that of the large columns. Then interiors of the windows are in very good condition. Wood sills include grilles that provide heat from ducts concealed in the walls.

North reading room.

Original shelving at east wall.

The current flooring is vinyl composite tile, in 12" squares, which may have been installed over the original cork that was indicated on the original drawings. The material is in good condition but would presumably be replaced as part of a restoration.

The acoustic tile at the ceiling may be the original. It is not clear how well the acoustics in these spaces function, and a full renovation likely will require access above the ceilings for systems. New tile or other acoustic ceiling might be needed.

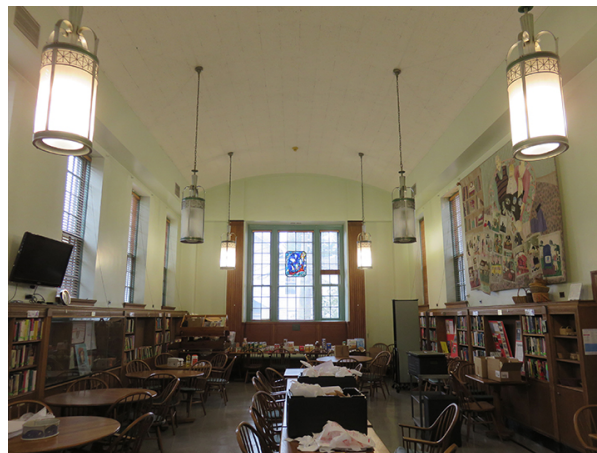
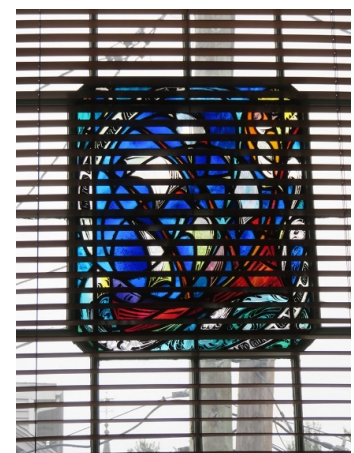
The colored, leaded glass panels at the north and south ends, as noted in the Windows section of the report, are important pieces, and most noticeable at the interior. These were designed by Connick Studios, based on Robert Frost's "Mending Wall" and Emily Dickinson's "There is no Frigate like a Book". The piece based on Robert Frost's poem was installed during the building dedication in 1939, with Robert Frost in attendance. These glass panels look to be in good condition but should be assessed further and care taken to preserve them.

South reading room.

Art glass seen through blinds.

Detail originally included stenciling at the upper walls, though that was eliminated when duct soffits were added in 1993. If the spaces are to be restored, duct soffits could possibly be eliminated and stenciling reintroduced.

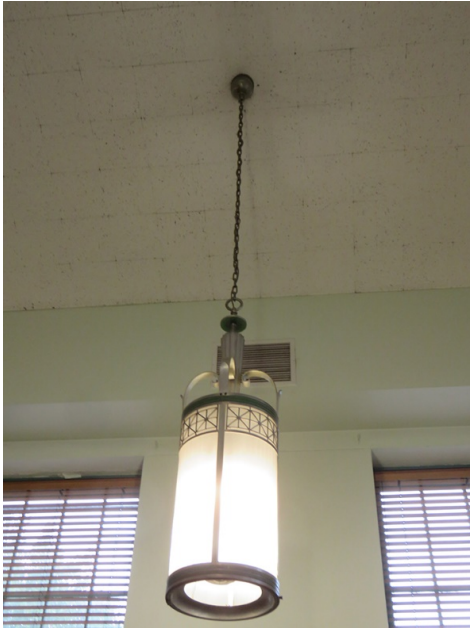
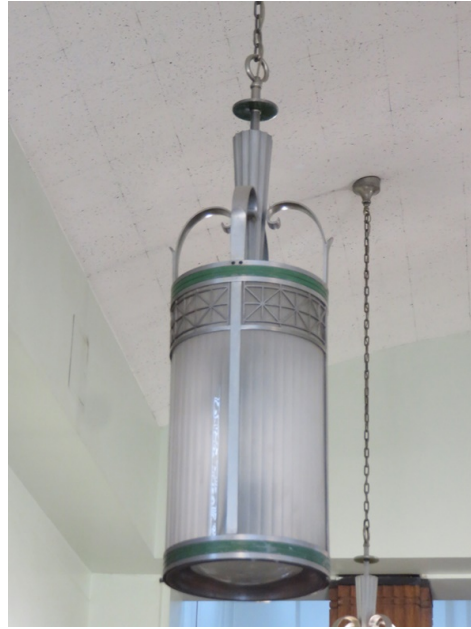
The original pendant light fixtures remain, and at least some are functional. These, along with the art glass at the end windows, are the most distinctive elements in the spaces.

Pendant light fixture lit.

Detail of aluminum fixture.

CONDITION: Good.

RECOMMENDATION: Remove existing vct flooring and provide cork or other flooring. Restore pendants and retrofit with LED lighting. Conceal HVAC system and reuse original grilles. Remove duct soffits and reintroduce stenciling. Retain shelving. Salvage lights and shelves for reuse elsewhere if spaces are not retained.

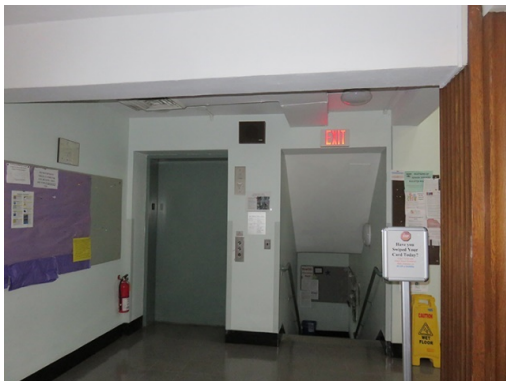
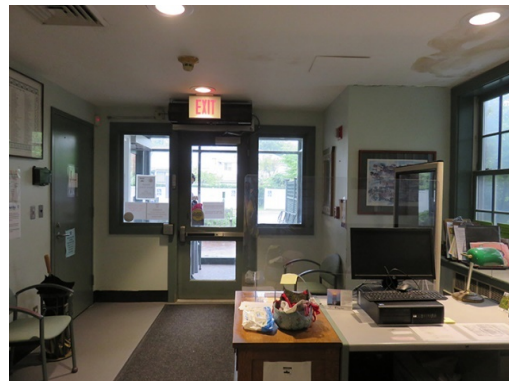
The original stack area at the first floor was converted in the 1993 renovation for use as the elevator lobby, toilet rooms, and access from the new west entry. Partitions were added and all finishes removed and replaced with new. This space does not retain any of its original interior.

Elevator lobby with stair up from west entry area.

Entry space looking to glass vestibule at rear of building.

CONDITION: Good.

RECOMMENDATION: Retaining these spaces is likely infeasible as part of a renovation/addition. Nothing in these spaces is important to keep.

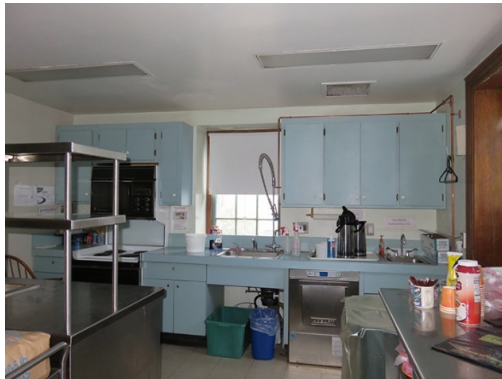
The space to the west of the Dining space is currently a kitchen, housing commercial level equipment and finishes appropriate for that use. A renovation would dictate full removal down to the structure, regardless of the new use.

Commercial equipment in Kitchen.

CONDITION: Fair.

RECOMMENDATION: This one-story space likely would be removed as part of the project. If it were to be retained, it would be stripped down to structure. The windows could possibly be retained, similar to other exterior windows.

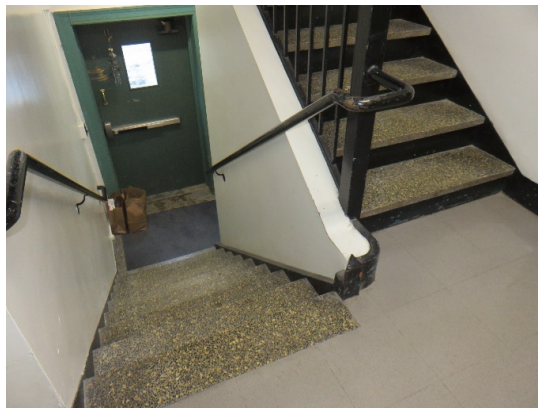
This stair connects the three levels of the library floors as well as providing egress at grade level at the west. Terrazzo treads look to be original and are in good condition. Wall-side railings added in 1993 in order to comply with code.

Stair down to grade at west.

CONDITION: Good.

RECOMMENDATION: If this is retained, some upgrades to comply with code requirements may be needed.

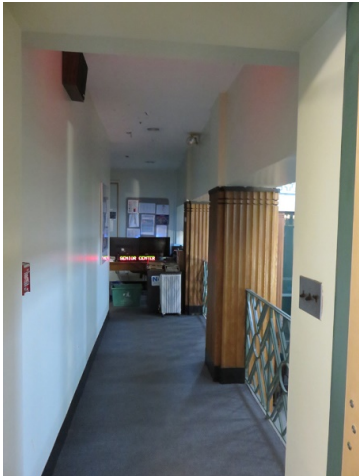
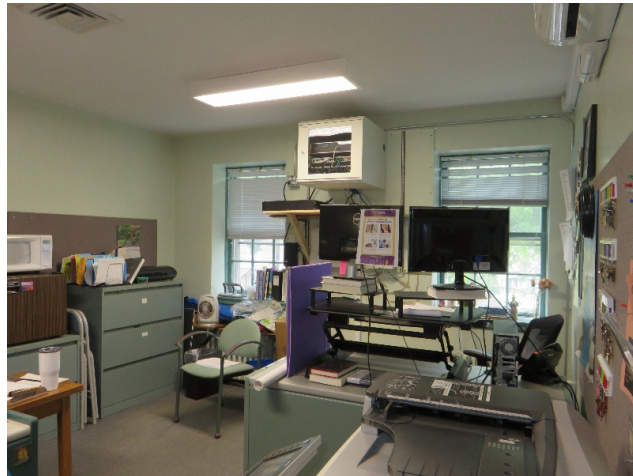
The mezzanine area originally was the upper level of the stacks and is now used as offices. The small office area has drywall finishes and fluorescent lighting. The one distinctive element of the mezzanine area is the open railing overlooking the Lobby space. The railing is not a code-compliant height and would require a supplemental railing as part of a renovation. The elevator does access this level. The overall occupancy of this level is minimal, so the one egress stair is code-compliant.

Hallway at mezzanine.

Office area with windows to the west.

CONDITION: Good.

RECOMMENDATION: If this is retained, an additional railing of some sort would be required to meet code requirements of 42" in height.

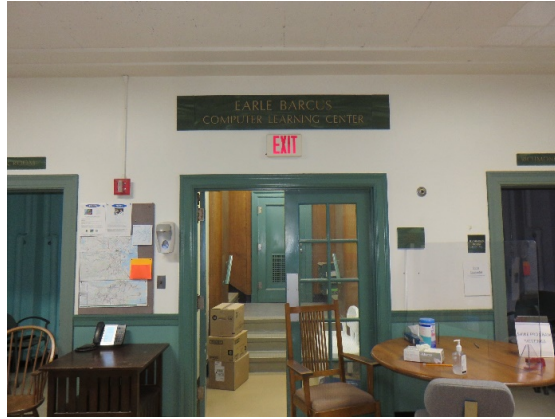
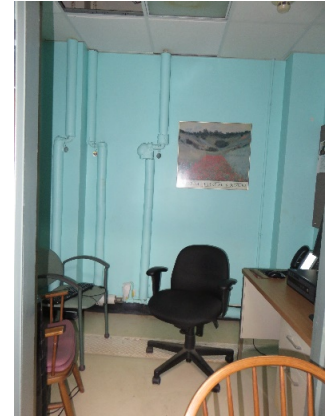
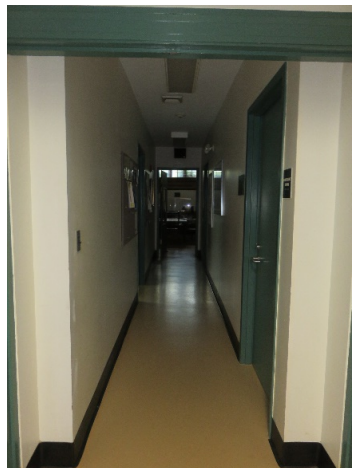
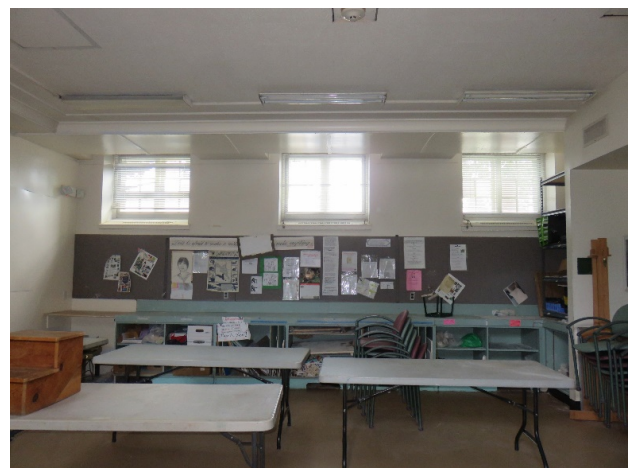
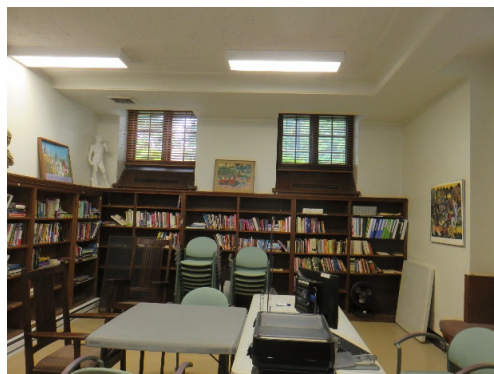
The "ground floor" area is actually 6' below street grade. It was designed originally to house the Children's Reading Room and the Community Room, so these were finished spaces and the entry stair provided clear circulation to get there. Some of the original millwork detail remains at areas such as the central space that is currently used for computers. This includes wood doors with glass lites and painted wood casings, along with wainscoting at the walls. Wood windows also remain, with interiors in very good condition. The sills of these windows are approximately 7'-6" above the floor level.

View from center area toward east stairwell.

Original closet is now as office.

South corridor.

Art room with windows facing onto Walnut Street.

Library space at south end.

CONDITION: Fair.

RECOMMENDATION: Remove all finishes and partitions down to the basic structure and provide all new.
