Subject: **Preliminary Geotechnical Engineering Report  
Proposed New Center for Active Living  
345 Walnut Street, Newtonville, MA 02460  
PSI Project No.: 04461013**

## PRELIMINARY GEOTECHNICAL ENGINEERING REPORT

For the Proposed  
**New Center for Active Living**  
345 Walnut Street  
Newtonville, MA 02460

**PSI PROJECT NO. 04461013**

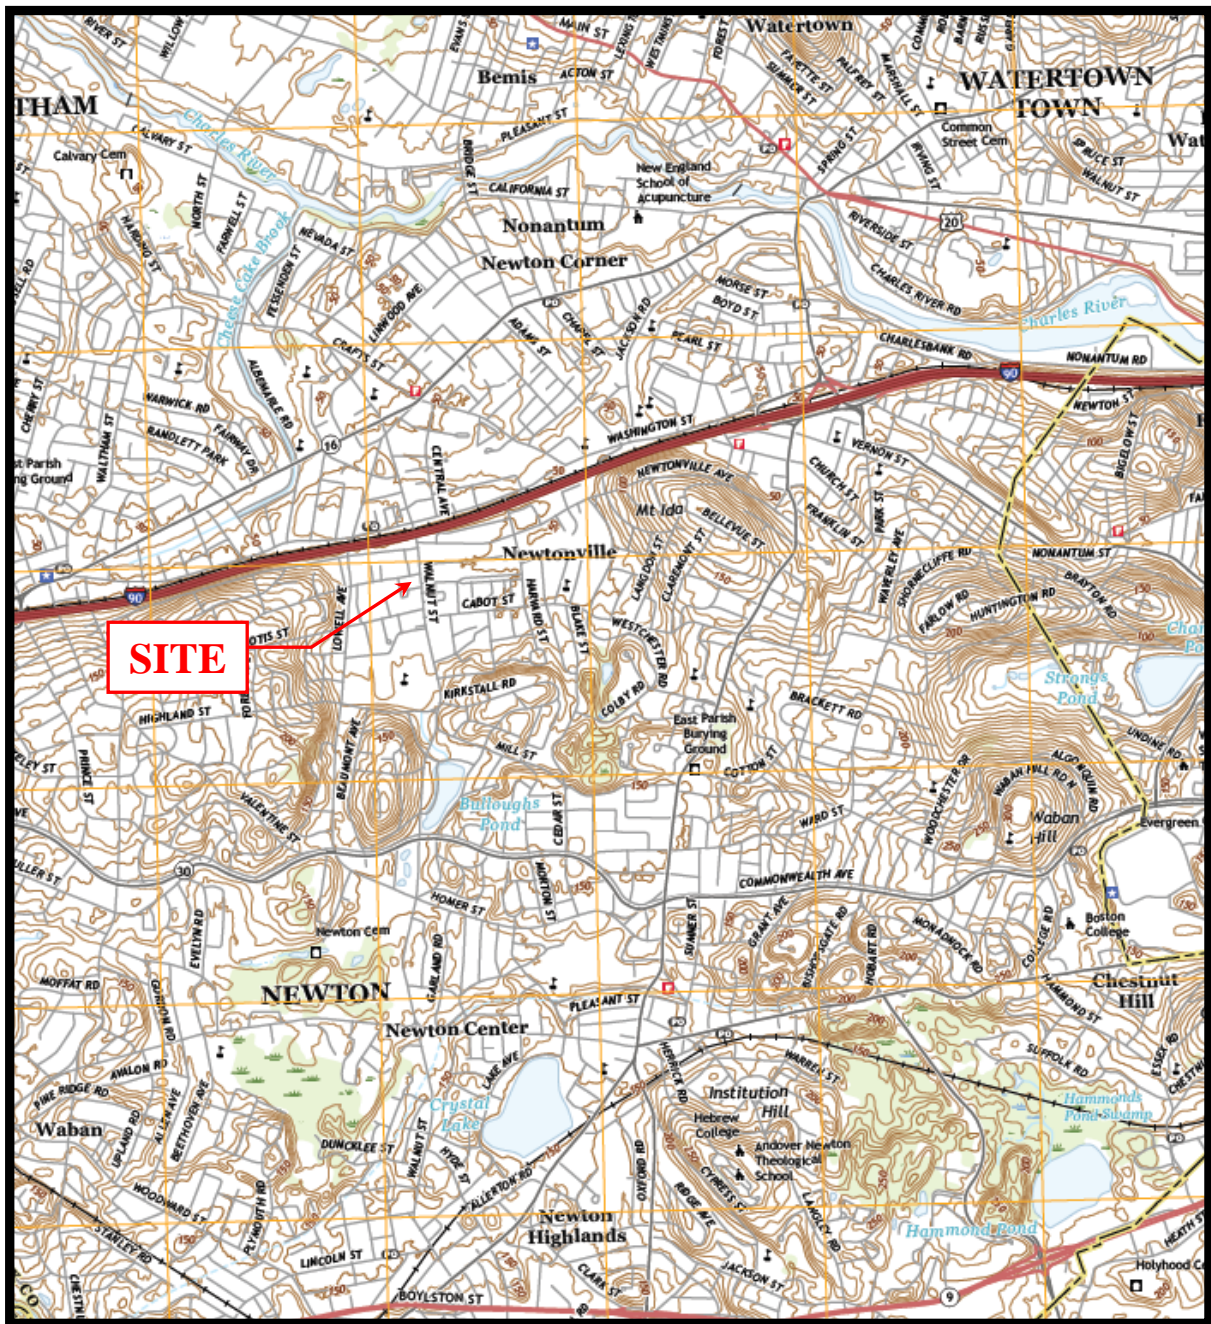
**Figure 3: Surficial Geology**

Based on the “Plate 5 Surficial Geologic Map of the Newton Quadrangle, Massachusetts” compiled by C.M. Brankman in 2004, the surficial geology of the project site is glacio-fluvial deposits, which consists of primarily sand and gravel with cobbles, as shown in *Figure 3, Surficial Geology*. The subsurface conditions encountered below the fill material at this site generally fits the geologic description.

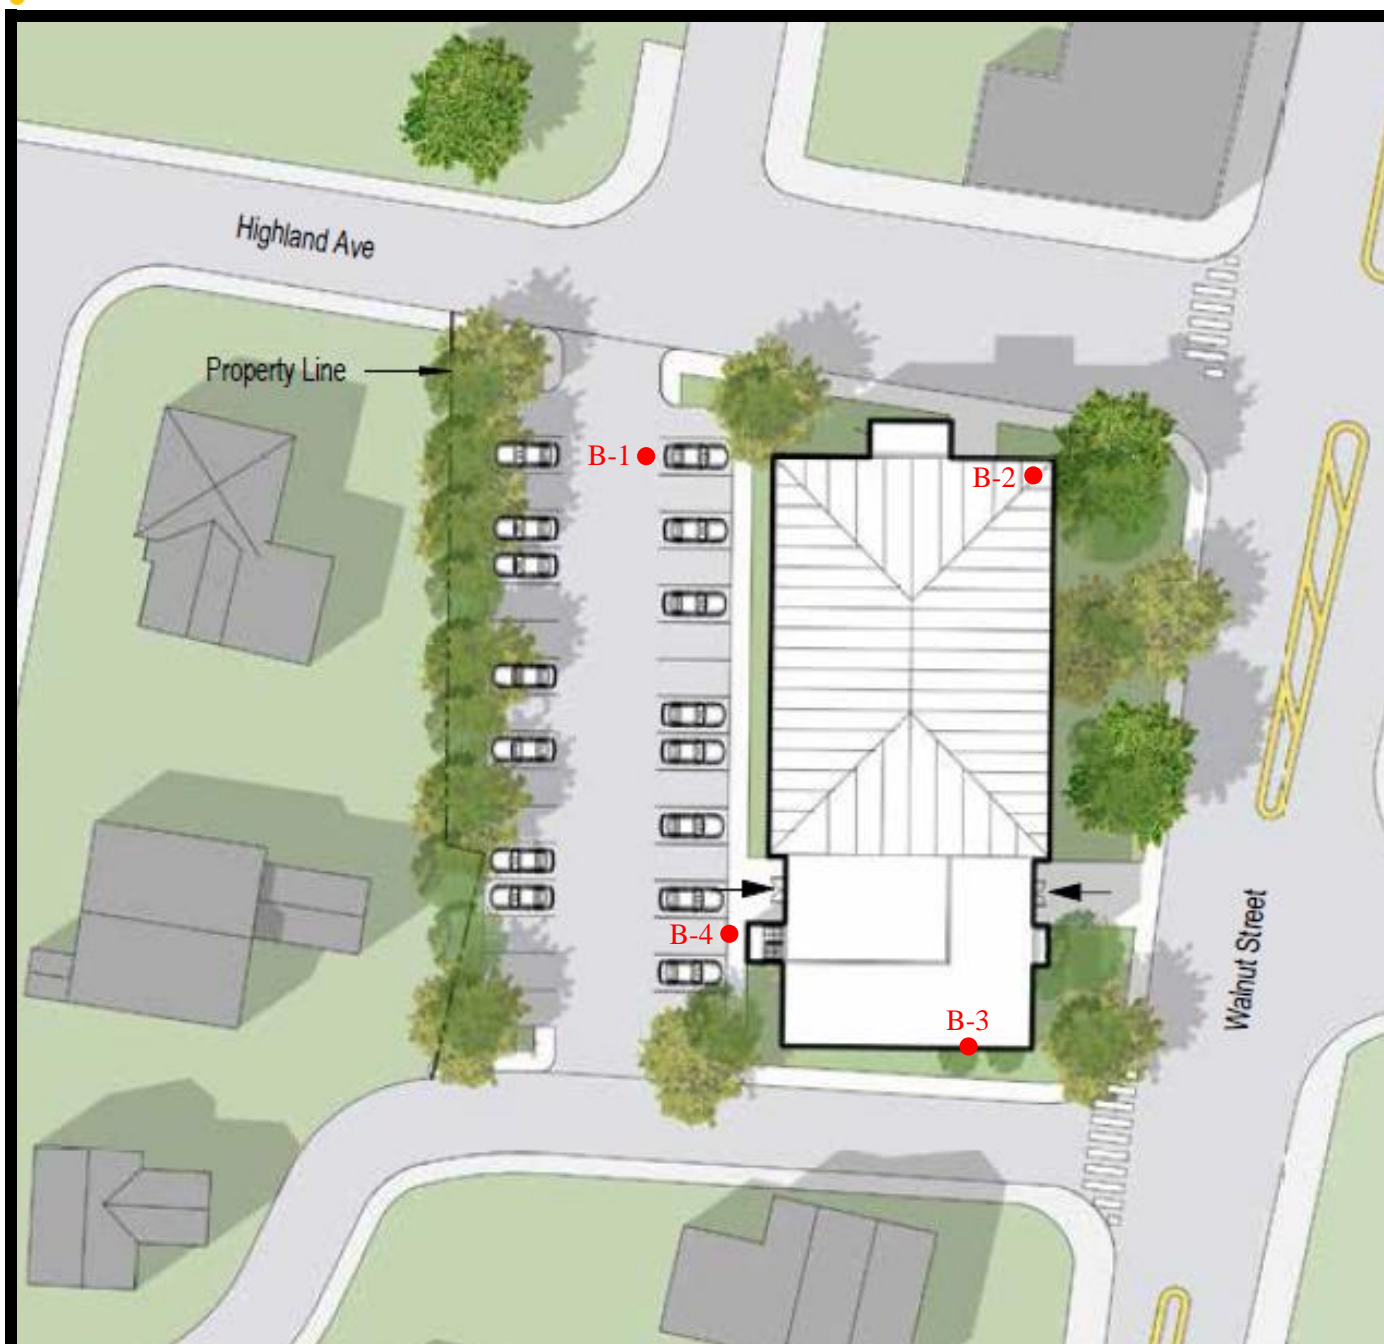
● Boring Location

- Base Plan is Newtonville New Construction: 4 Stories Site Plan (dated 8/26/20) provided by Client.
- Borings were located in the field by PSI. Locations are approximate.
- Borings drilled on September 23, 2020 by Soil X Corp. of Leominster, MA.

Soil X Corporation of Leominster, MA drilled four soil test borings on September 23, 2020 at the approximate locations shown in *Figure 2, Boring Location Plan*. The borings were drilled near or within the proposed building footprint. Due to the proposed building footprint being within part of the existing building footprint, the borings were located as close to the proposed building footprint as feasible. A PSI representative observed the exploration activities for this project, retrieved soil samples for classification and testing, and prepared the attached Soil Test Boring Logs.

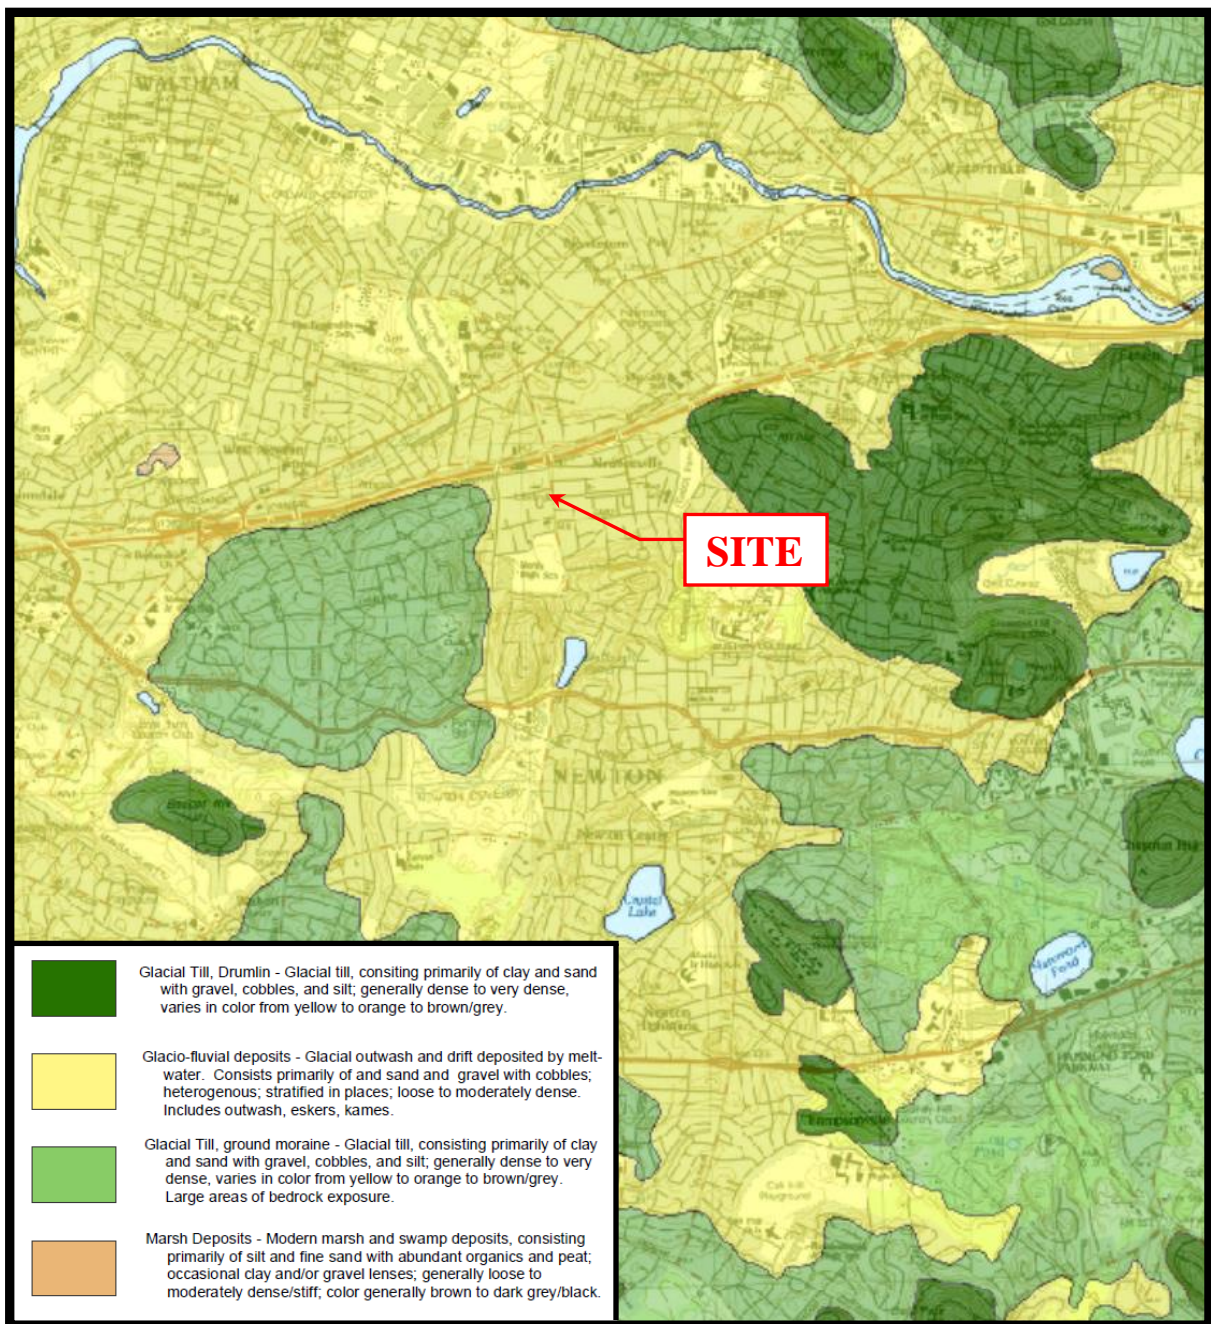
### FIGURE 3: SURFICIAL GEOLOGY

**REFERENCE:** "Plate 5 Surficial Geologic Map of the Newton Quadrangle, Massachusetts"  
Compiled by C.M. Brankman - 2004

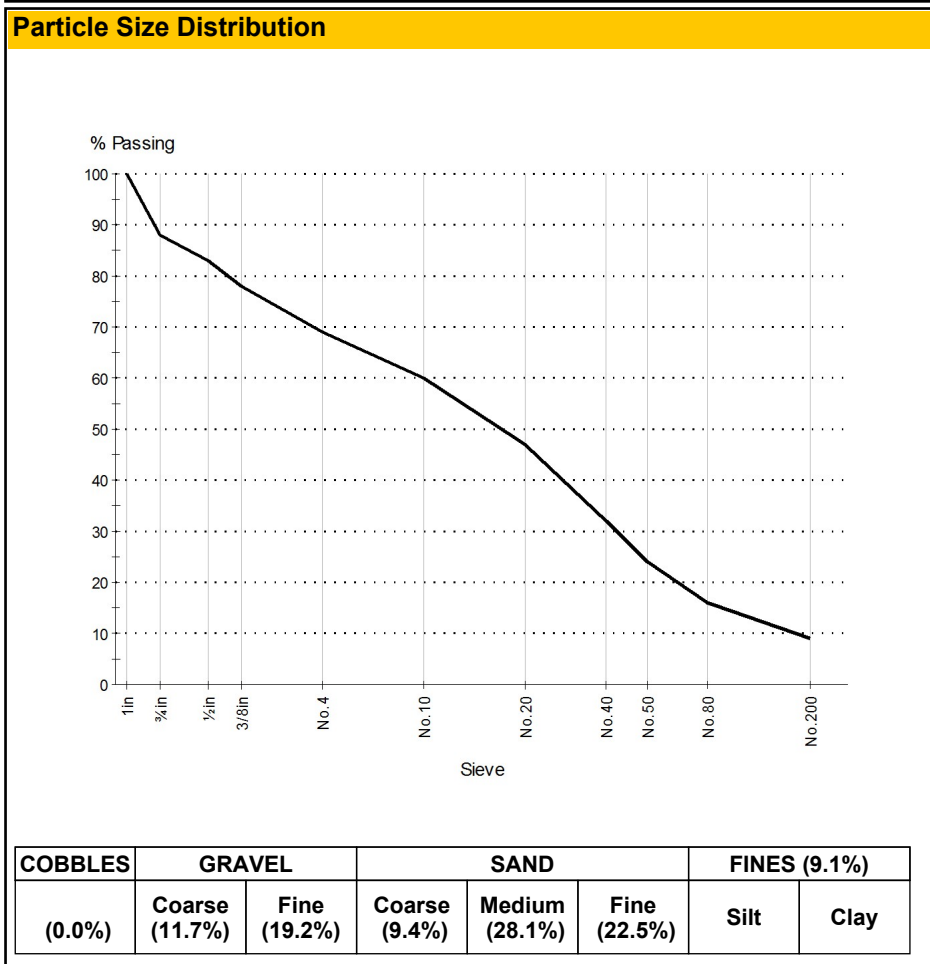
**Sample ID:** 04461013-1-S1  
**Client Sample ID:**  
**Date Sampled:** 09/23/20  
**Sampled By:** PSI  
**Specification:** No Spec. Sieve  
**Supplier:**  
**Source:** On-Site  
**Material:**  
**Sampling Method:** Soil Boring Split Spoon Sample  
**General Location:** B-4 (0.5'-2.5')

**Grading: ASTM C 136, ASTM C 117**

Boring No.	Sample No.	Sample Depth (feet)	USCS Classification <sup>1</sup>	Moisture Content (%)	Fines Content (%)
B-4	S1	0.5'-2.5'	Poorly-Graded Sand with Silt and Gravel (SP-SM)	2.9	9.1
B-4	S2	2.5'-4.5'	Well-Graded Sand with Silt and Gravel (SW-SM)	9	12
B-3	S3	5'-7'	Well-Graded Sand with Silt and Gravel (SW-SM)	1.8	8

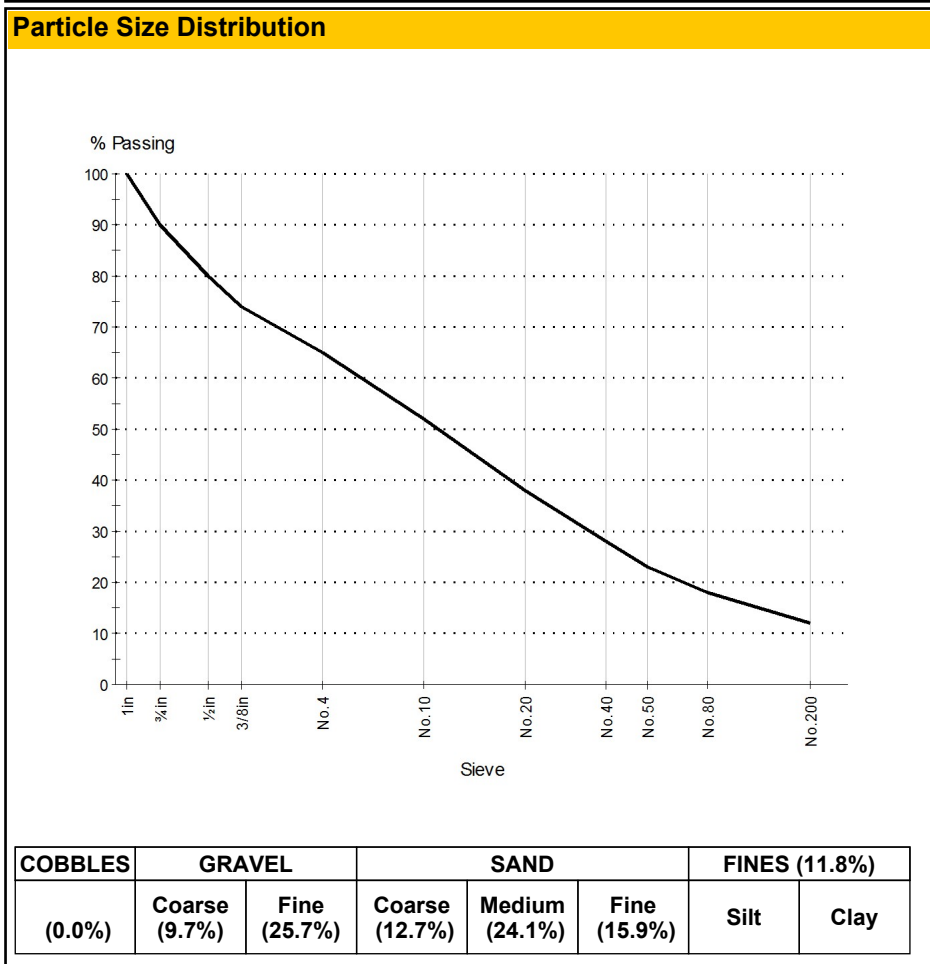
**Sample ID:** 04461013-1-S2  
**Client Sample ID:**  
**Date Sampled:** 09/23/20  
**Sampled By:** PSI  
**Specification:** No Spec. Sieve  
**Supplier:**  
**Source:** On-Site  
**Material:**  
**Sampling Method:** Soil Boring Split Spoon Sample  
**General Location:** B-4 (2.5'-4.5')

**Grading:** ASTM C 136, ASTM C 117

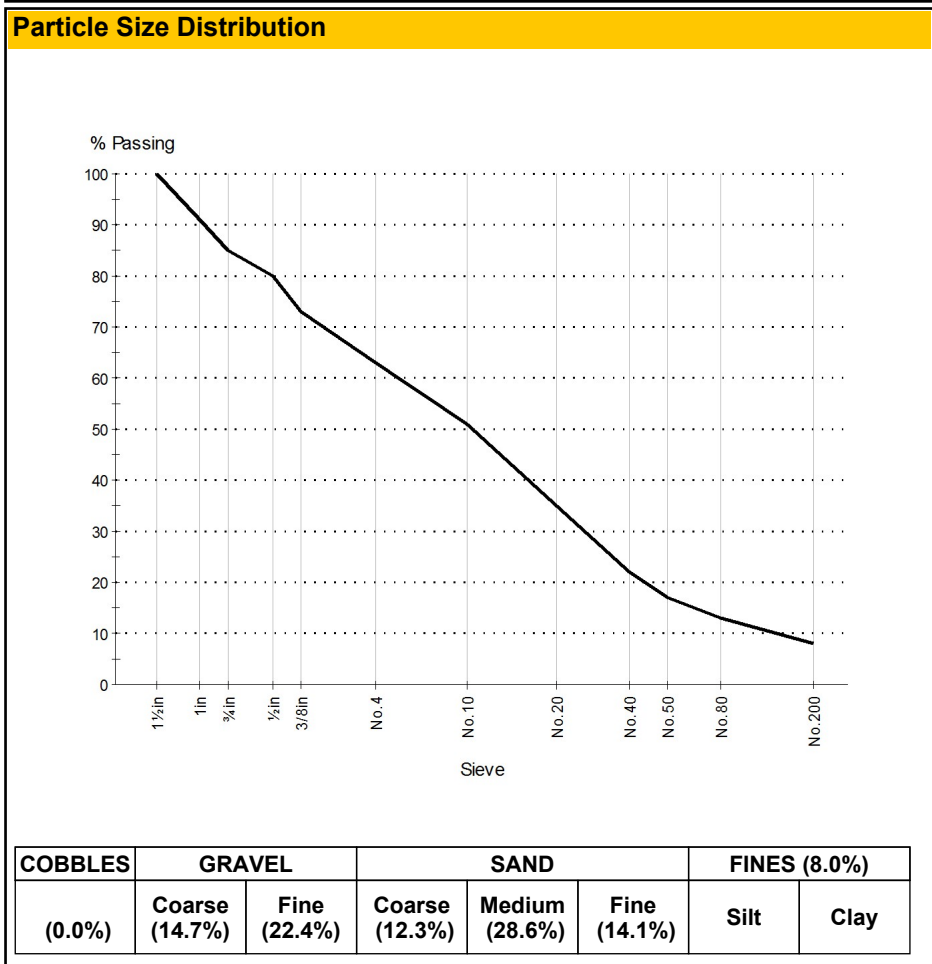
**Sample ID:** 04461013-1-S3  
**Client Sample ID:**  
**Date Sampled:** 09/23/20  
**Sampled By:** PSI  
**Specification:** No Spec. Sieve  
**Supplier:**  
**Source:** On-Site  
**Material:**  
**Sampling Method:** Soil Boring Split Spoon Sample  
**General Location:** B-3 (5'-7')

**Grading: ASTM C 136, ASTM C 117**
